Manhole Inspection Summary

Manhole # S43WW_018MH

Insp Date: **2/16/07 8:16 AM**

Location Address: **1601 31ST ST**

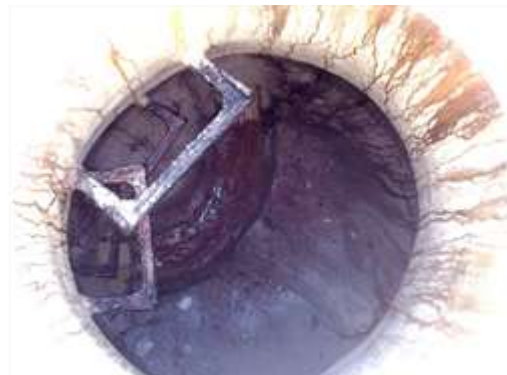
Top View

Adjustment infiltration. Bench debris.

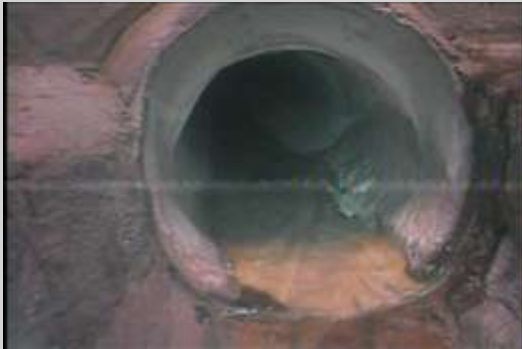
12 in. Circular Gravity Sewer Pipe Out @ 12 O'Clock

Pipe Material: **Unknown** ☒ Pipe Lined

Invert Depth: **7.00** (ft.) Flow Characteristics: **Slow**

Infiltration: **None** Pipe Seal Cond: **Unknown**

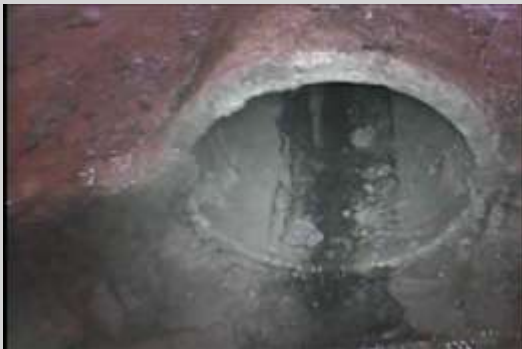
6 in. Circular Gravity Sewer Pipe In @ 5 O'Clock

Deposits: ☐ None ☐ **Mud** ☐ Sludge ☒ **Debris** ☐ Grease

Silt Depth: **0** (in.) Deposits Extent: **Light**

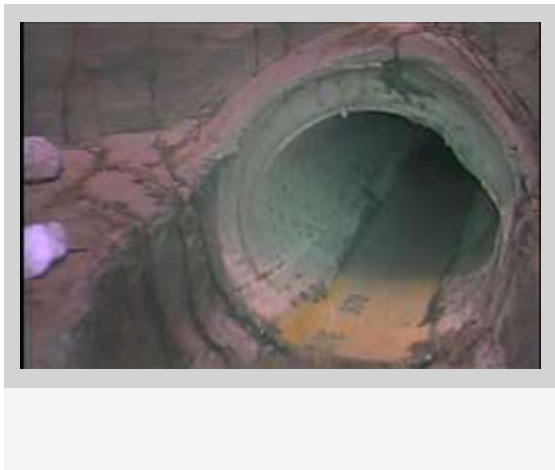
12 in. Circular Gravity Sewer
Pipe In @ 9 O'Clock

Deposits: ☐ None ☒ **Mud** ☐ Sludge ☐ Debris ☐ Grease

Silt Depth: **0** (in.) Deposits Extent: **Light**

Infiltration: **Evidence** Pipe Seal Cond: **Cracked**
